## Geological Evidence of Shoreline Erosion and Mitigation Challenges

Anthony Woode, David Kwame Amoah

*Department of Civil Engineering, Accra Polytechnic, P.O.Box 561, Accra, Ghana  
Email: [pstwoode@yahoo.com](mailto:pstwoode@yahoo.com), [daveamoah2@yahoo.com](mailto:daveamoah2@yahoo.com)*

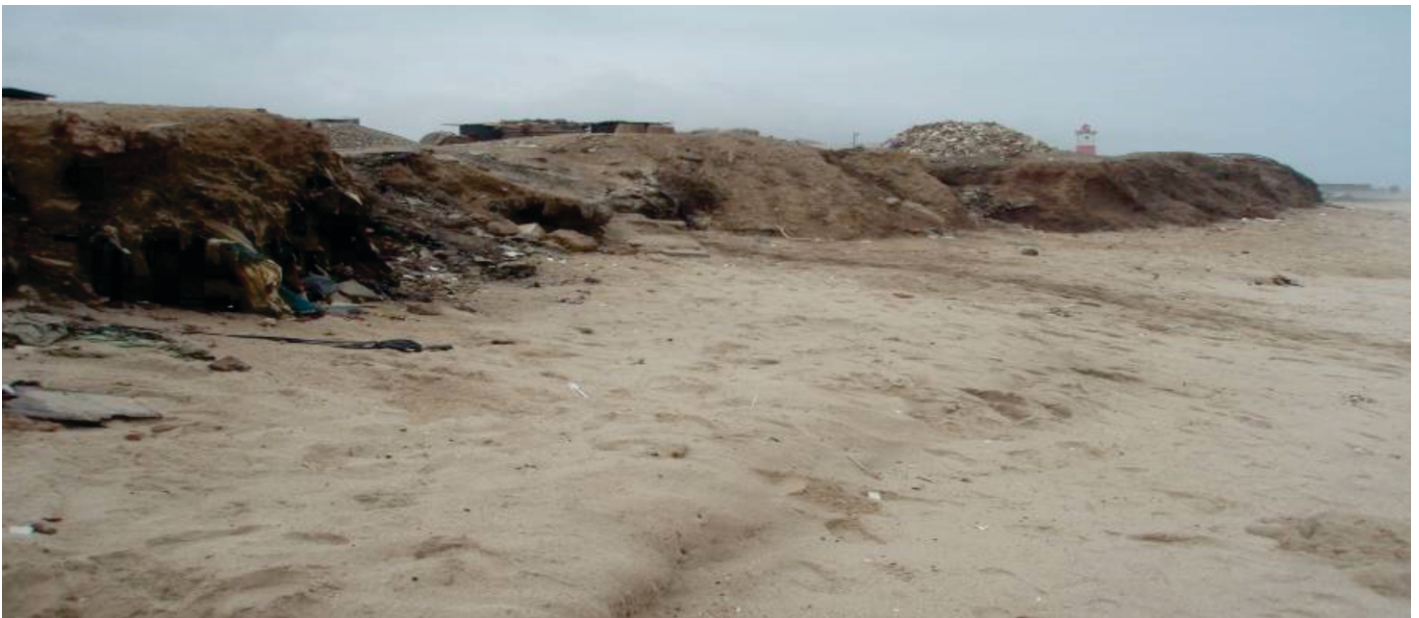
Plate 1: Partly eroded beach nourishment at James Town beach

A beach nourishment activity at the James Town beach (Plate 1) is meant to serve as a buffer zone to prevent erosion. The challenge with beach nourishment is that it often needs to be repeated to maintain the presence of the beach, and should be used in combination with hard engineered structures as it has been done at Sakumono (Plate 3). The beach nourishment at James Town is gradually being eroded (Plate 1).

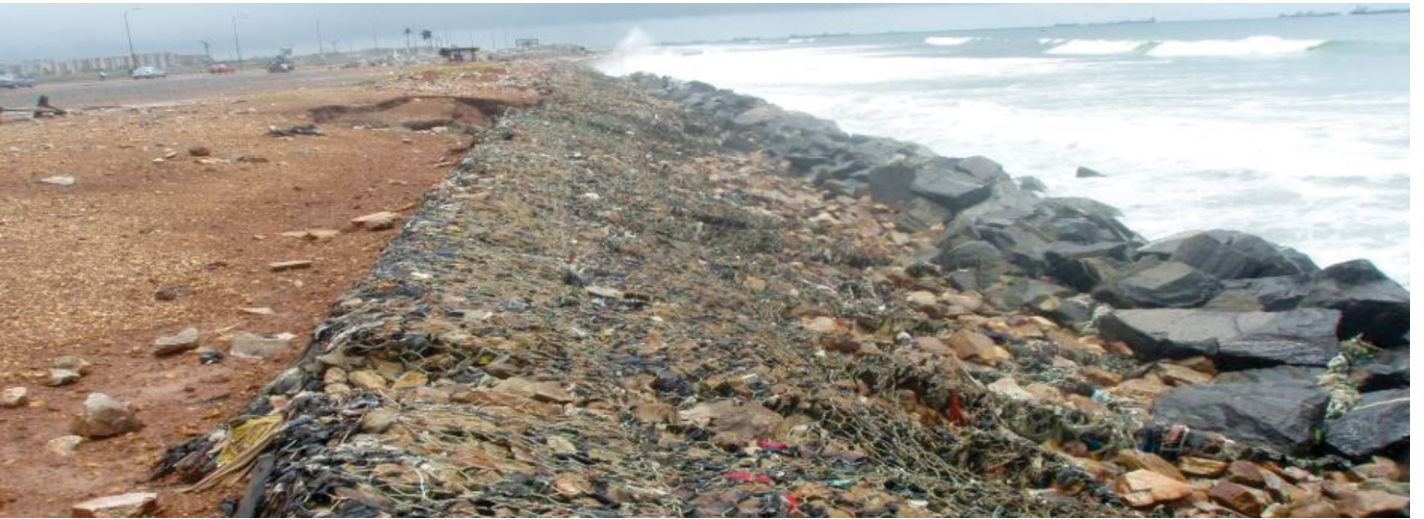
Plate 3: Beach nourishment, gabion and riprap at Sakumono beach. Beach nourishment shows signs of erosion

Gabion revetments have extensively been used to protect the shoreline from erosion (Plate 3). The major challenge with its use is with regard to the fact that in some places the metal baskets holding the cobbles in place are all rusted.

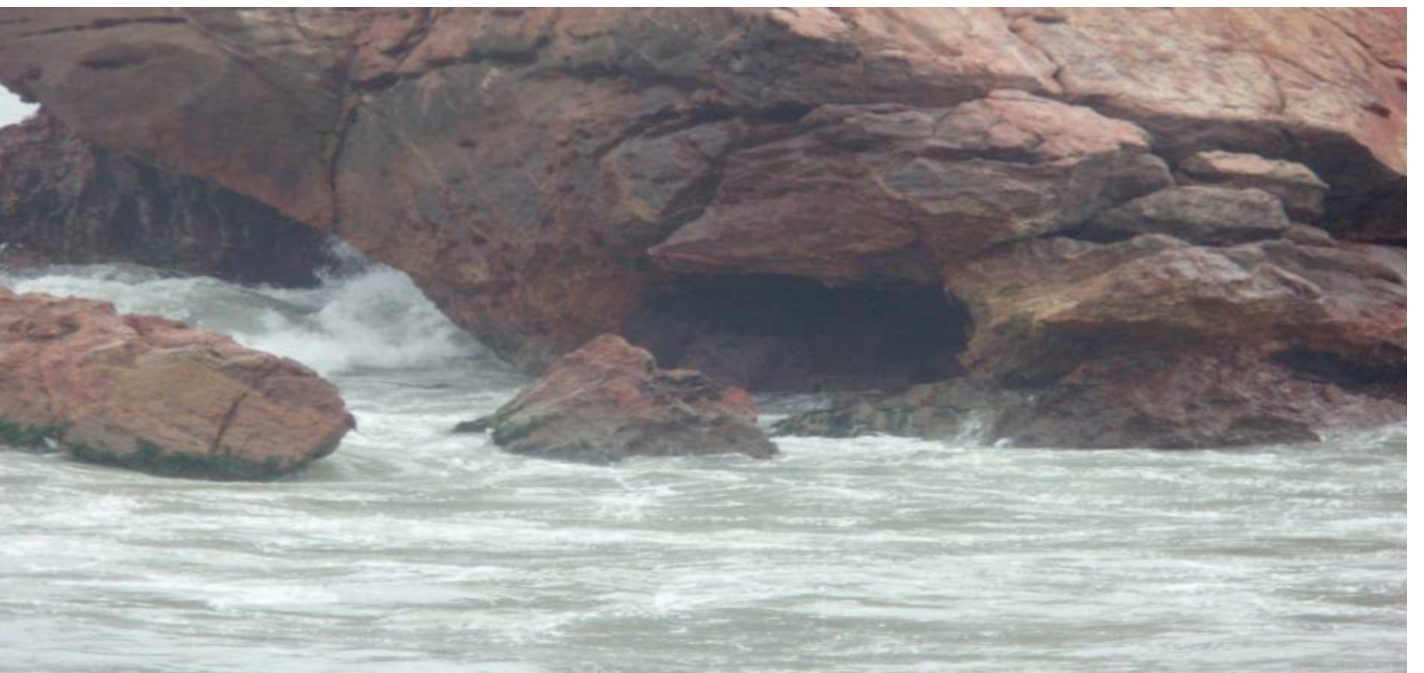
Plate 5: Caves in rocks at Osikan

High sea waves during high tides result in rapid undercutting of steep coastal cliffs (Plate 4) especially in weak soil. This undercutting has resulted in landslides. Apart from the high sea waves, which usually occur during high tide, the retreat of coastal cliffs (Plate 4) is also attributed to the engineering interventions up-current, such as the jetty at Accra old harbour, behind the James Fort Prisons, and the jetty located at Korle Gonno (Plate 2). The net effect is the alteration or loss of coastline ecosystems and properties and livelihood. Caves are common in steep cliffs of hard rocks (Plate 5). They are formed by sea waves gradually causing tunnels in rocky coastlines. Caves erode into arches and are common in rocks which seem to have been 'baked' around fault zones at the Osikan beach. Continued erosion has caused the collapse of some arches leaving behind sea stacks and stumps.

Budetta et al., (2000) studied the relation between the rate of erosion of coastal rocks and soils and the uniaxial compressive strengths of the soil and rock masses forming coastal cliffs. They obtained a relationship between the mechanical strength of the soil and rock masses and the rate of erosion, which indicates that the stronger the soil and rock masses the lower the rate of erosion. It was observed during field surveys that erosion is severe in the thin layers of sandstones inter-bedded with shale. The result is the formation of caves with widths of less than 1metre. The mudstone shows very severe erosion characterized by caves of widths greater than 1metre. The massive sandstone shows the least erosion evidence by the presence of holes of low diameter.
